**California State Board of Equalization**  
450 N Street, Sacramento, California 95814

**Indoor Air Quality/Odor Assessment**  
**June 2011 – January 2012**  
**Draft Report**

*Project No. 2372.02-572*

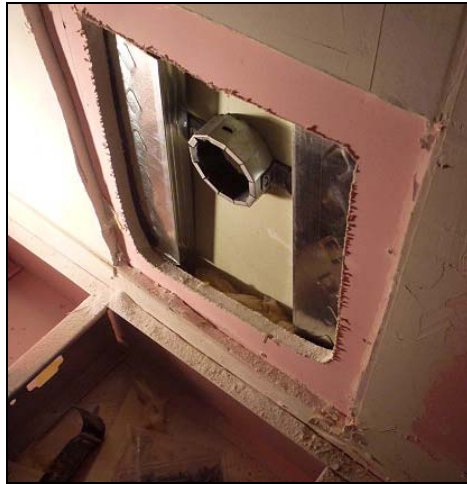
In order to identify or eliminate the building core interstitial spaces as potential sources of odor, thirty-one (31) sampling ports were installed to access the main vertical shafts of the building (see Figures 1 and 2). The ports were designed to meet NFPA and California State Fire Marshall inspection scrutiny. The sampling ports were positioned above the hard ceiling in the restrooms or above suspended ceiling tiles in the hallways to allow the use of sample collection equipment without disturbing the normal tenant work spaces.

*Fire-Rated Sampling Port*

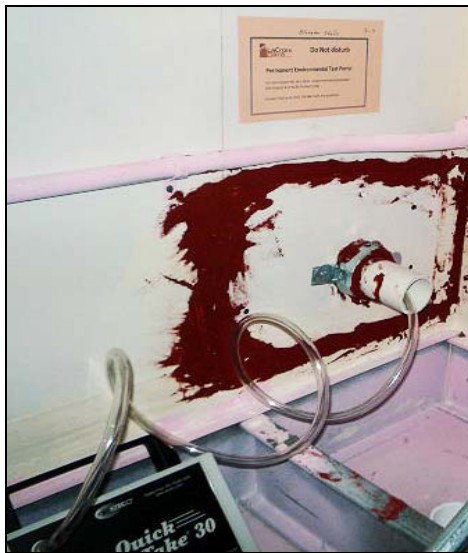
Visible mold growth (VMG) had been previously identified during limited destructive testing in some of the building core interstitial spaces. Therefore, on November 4, 2011, a total of thirty-four (34) spore trap samples were collected, one from each core interstitial space sampling port on Floors 2 and 21, and three (3) exterior background samples. The samples from Floor 2 served as background comparison samples for the samples collected on Floor 21. Each sample was collected at a sampling rate of 15 liters per minute for 5 minutes. The samples were submitted to EMLab P&K (EMLab) of West Sacramento under standard chain-of-custody. The laboratory reports are attached in Appendix A.

*Spore Trap Sampling through Sampling Port*

In general, with the exception of three spore trap samples collected from the south-southwest core sample locations, all of the spore trap samples were unremarkable. In some samples, no airborne spores were detected. The spore trap samples collected from core sample locations 21-13, 21-14, and 21-16, showed elevated concentrations of *Penicillium/Aspergillus* (Pen/Asp) type spores. The laboratory reports and chain-of-custody forms from EMLab are provided in Appendix A.

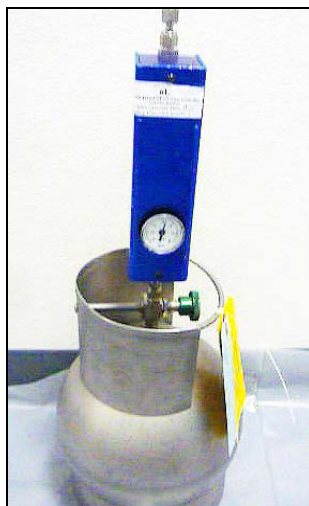
On November 4, 2011, thirty-one (31) volatile organic compound (VOC) core samples were also collected from core interstitial spaces on Floors 2 and 21 for laboratory analysis. The core samples from Floor 2 served as background comparison samples. The air samples were collected in summa canisters (6 liters) for approximately eight hours and analyzed using the EPA Method TO-15 for potential VOC and tentatively identified compounds. LCD employed the services of Environmental Analytical Services, Inc. (EAS) in San Luis Obispo, California, for the VOC core sample analyses. EAS is accredited by the National Environmental Laboratory Accreditation Program (NELAP). The EAS laboratory reports are attached in Appendix B.

*VOC Sample Collection via Summa<sup>®</sup> Canister*

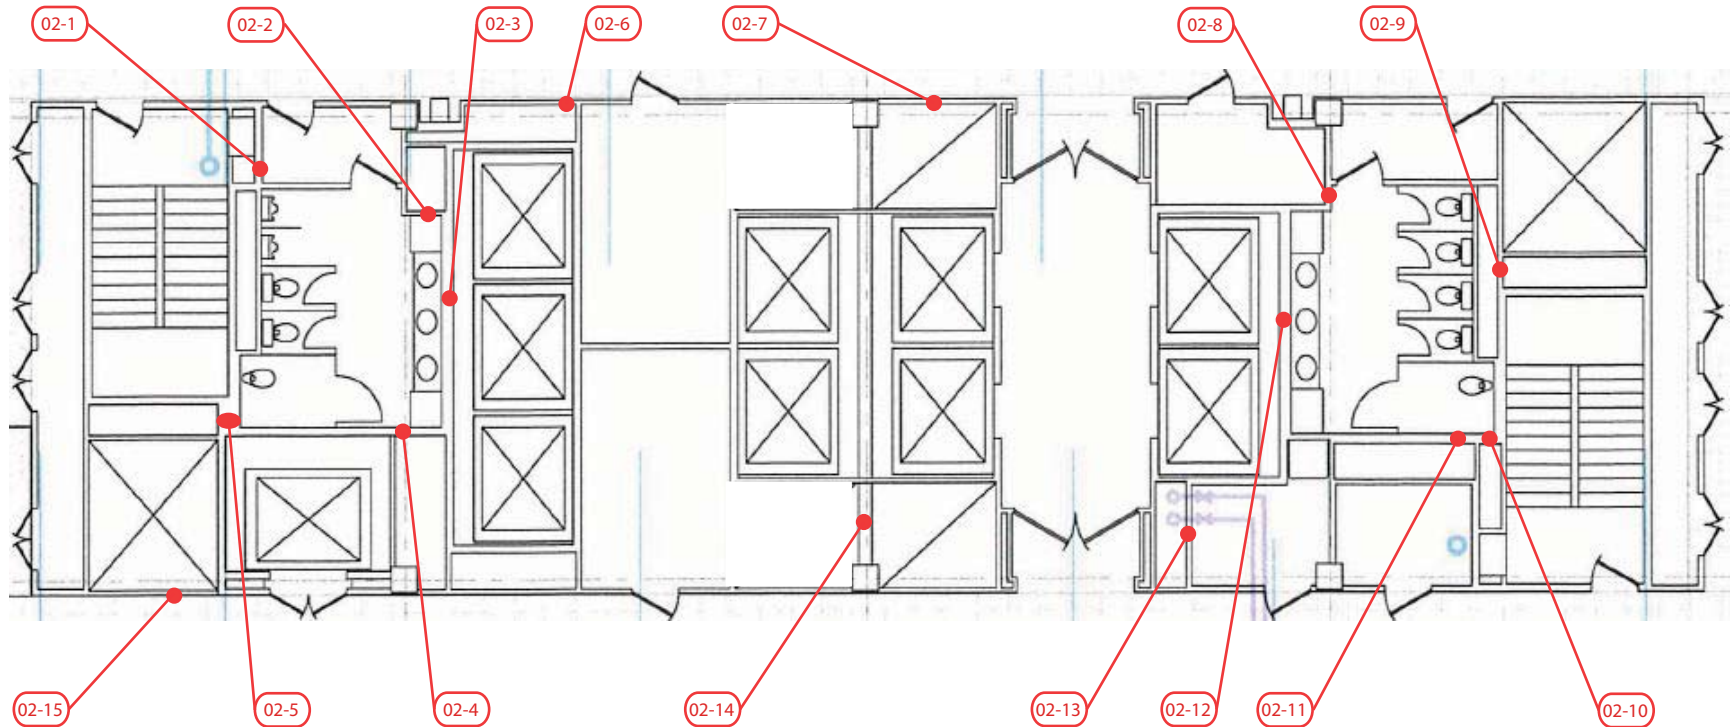
**Figure 1     Sample Port Locations – Floor 2**

Sample ports 1 - 5 are accessible through the men's bathroom ceiling access panel.  
Sample port 6 is accessible through the janitor closet ceiling access panel.  
Sample ports 8 - 12 are accessible through the women's bathroom ceiling access panel.  
Sample ports 7 and 13 - 15 are accessible by removal of ceiling tiles in corridor.

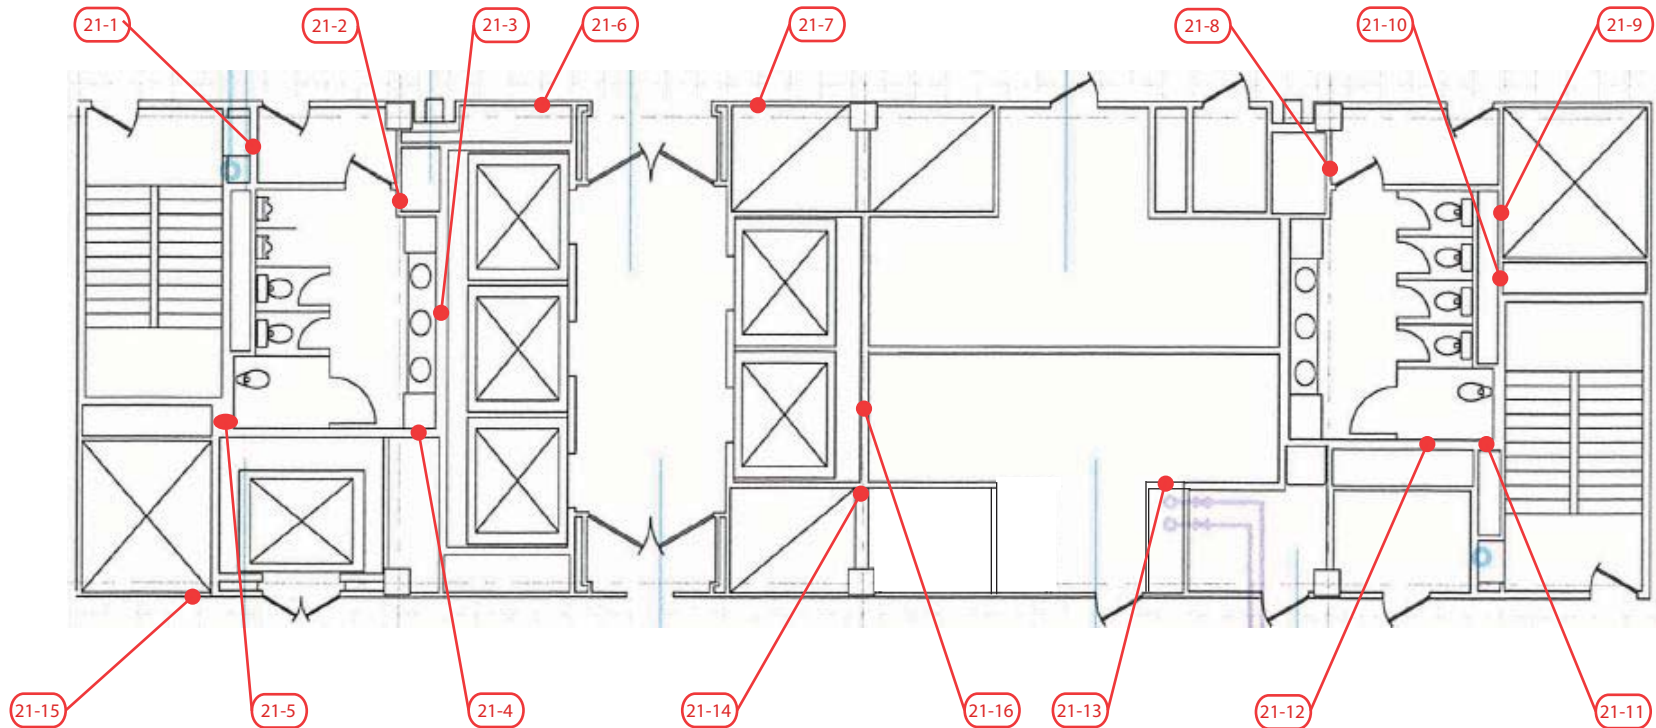
**Figure 2     Sample Port Locations – Floor 21**

Sample ports 1 - 5 are accessible through the men's bathroom ceiling access panel.  
Sample ports 6, 7 and 15 are accessible by removal of ceiling tiles in corridor.  
Sample ports 8 - 12 are accessible through the women's bathroom ceiling access panel.  
Sample ports 13, 14 and 16 are accessible through the mailroom ceiling access panel.
